PRODUCT BULLETIN

Effective Immediately: (For internal and external distribution) Vanguard 3000™ Firmware Upgrade Instructions

Firmware for the Vanguard 3000 cellular broadband router was recently updated to v5.1.3A. This product bulletin provides instructions for upgrading firmware in Vanguard 3000 routers currently running earlier versions of firmware v5.0.0 and up.

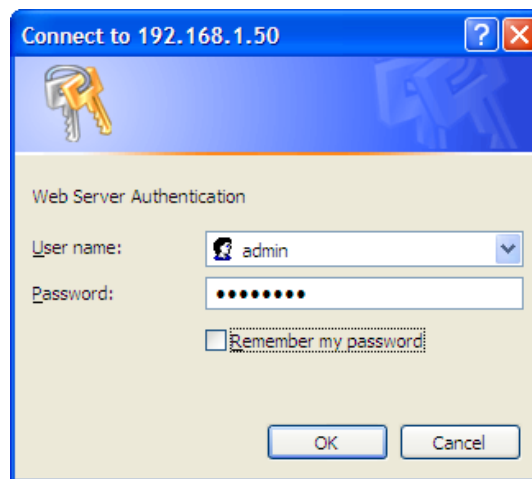
2. On the PC, open a web browser and enter the IP address of the Vanguard router in the address bar.
 - When the PC is connected to the Ethernet jack, the default IP address is 192.168.1.50.
3. A Web Server Authentication window appears. (This may take a up to 60 seconds after power is applied to the Vanguard 3000.)

- Enter the required User Name and Password (the default User Name is **admin** and the default Password is **password**) and click OK to log on.
4. Select **Firmware Update** from the main navigation menu to navigate to the Firmware Update page.

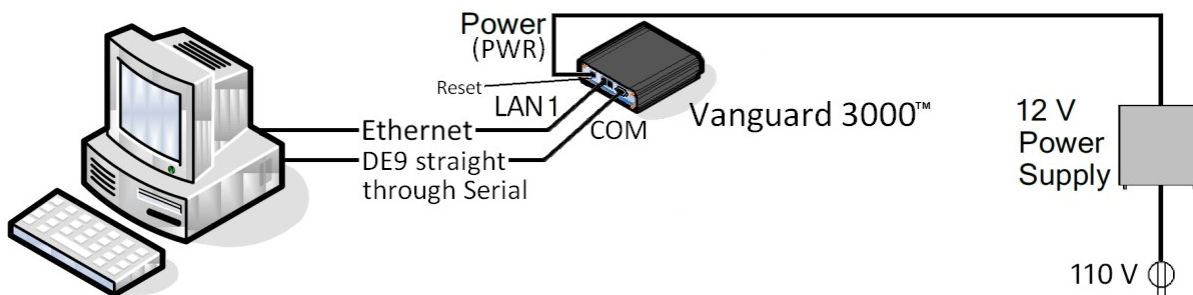
1. Create an empty directory on the PC and download the firmware release package file to this directory.
2. Cable the system. Connect the PC to the Vanguard 3000 router via Ethernet and DE9 straight-through serial cable.
 - a. Connect the Ethernet cable to the LAN 1 port of the Vanguard and plug the other end into the network port of the PC.
 - b. Connect the DE9 straight-through serial cable to the COM port of the Vanguard and connect the other end to the serial COM port of the PC.
